Xerox® WorkCentre® 56xx

Installation Guide

Scanning Issue Patch

22 August 2013

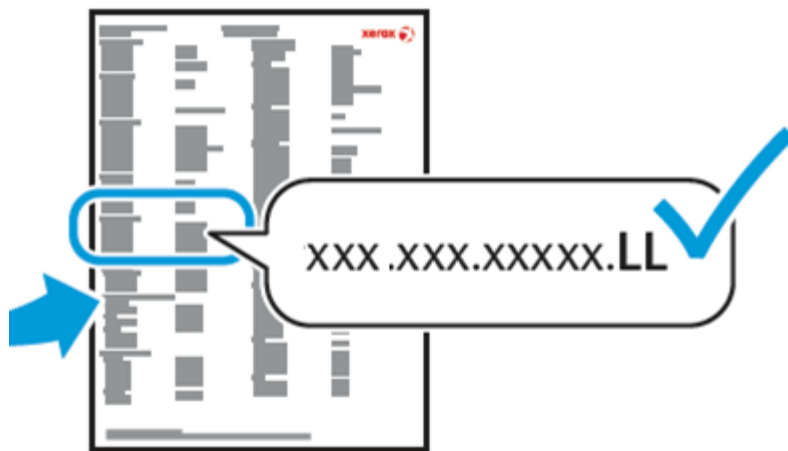
4. Patch Installation begins several minutes after the software file is submitted to the machine and may take up to 20 minutes. The machine automatically reboots once the installation is complete. The configuration report will append LL to the Network Controller version.
