Xerox® ColorQube® 93xx

Installation Guide

Scanning Issue Patch

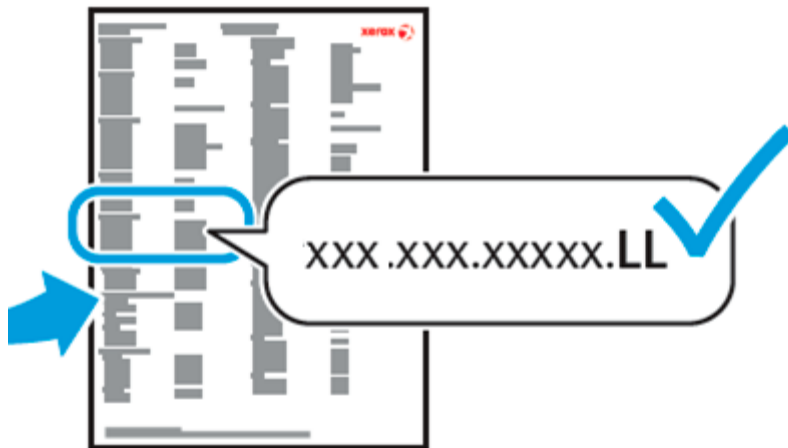
4. Patch Installation begins several minutes after the software file is submitted to the machine and may take up to 20 minutes. The machine automatically reboots once the installation is complete.
