# Xerox® WorkCentre® BookMark 40/55

## Installation Guide

### Scanning Issue Patch

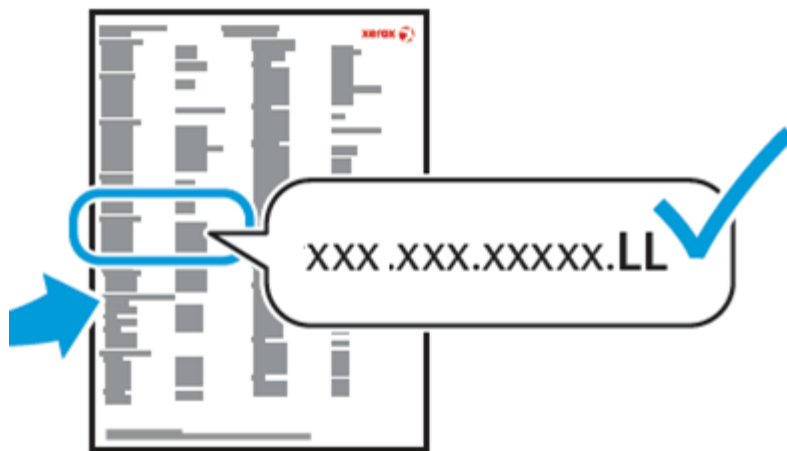
4. Patch Installation begins several minutes after the software file is submitted to the machine and may take up to 20 minutes. The machine automatically reboots once the installation is complete. The configuration report will append LL to the Network Controller version.

Once the patch installs, file sizes may be slightly larger. The patch appends .LL to the network controller version number on the printed configuration sheet and the **Configuration** page in CWIS. Another method to validate the patch install is with the new MIB object.
