# LL Patch Update

## What You Can Expect

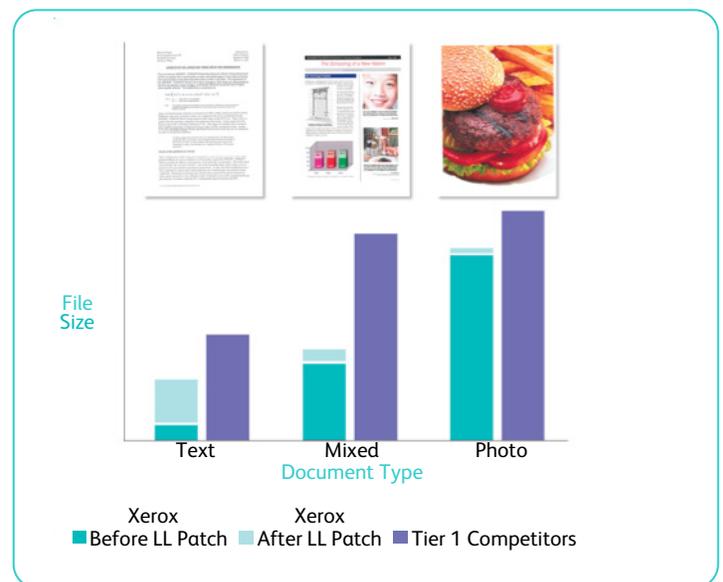
### File Size Comparison with the LL Patch

Test completed on a Xerox® WorkCentre® 7855 MFP and will be similar on a relative scale with other LL Patched devices.

There are no noticeable differences in the operation of your Xerox® MFP after the LL patch is installed. Xerox® MFPs will continue to use industry standard compression, but without the more aggressive file compression that may result in character substitution. Therefore, extremely small file sizes for text will no longer be offered. There will be minimal impact to file sizes for mixed and photo documents. All of these documents will continue to have very good compression with file sizes that are competitive in the industry based on Xerox testing (see chart on right).
